Pisinemo Intertie

PWSID No. 04000030

Sanitary Survey
March 24, 2016

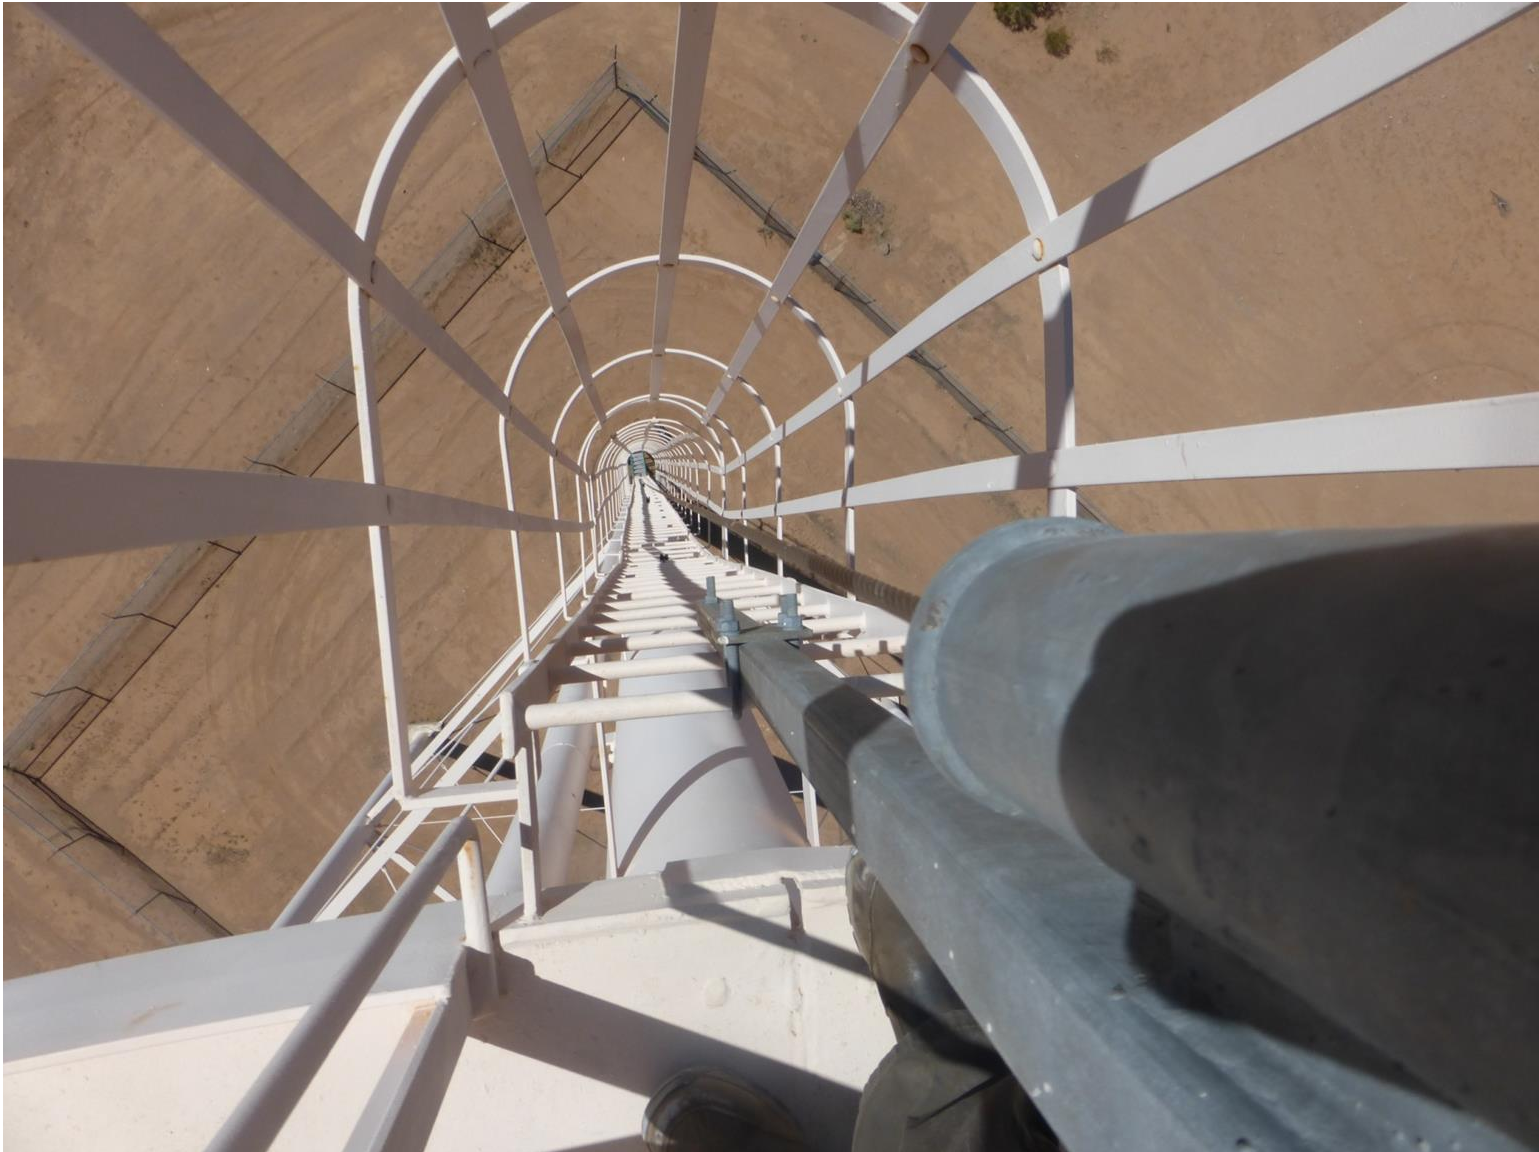
The ladder for the tank is equipped with a safety cage and safety cable. The cage opening is not equipped with a locking hatch, but there is a locking cover near the bottom of the ladder to help prevent unauthorized access.

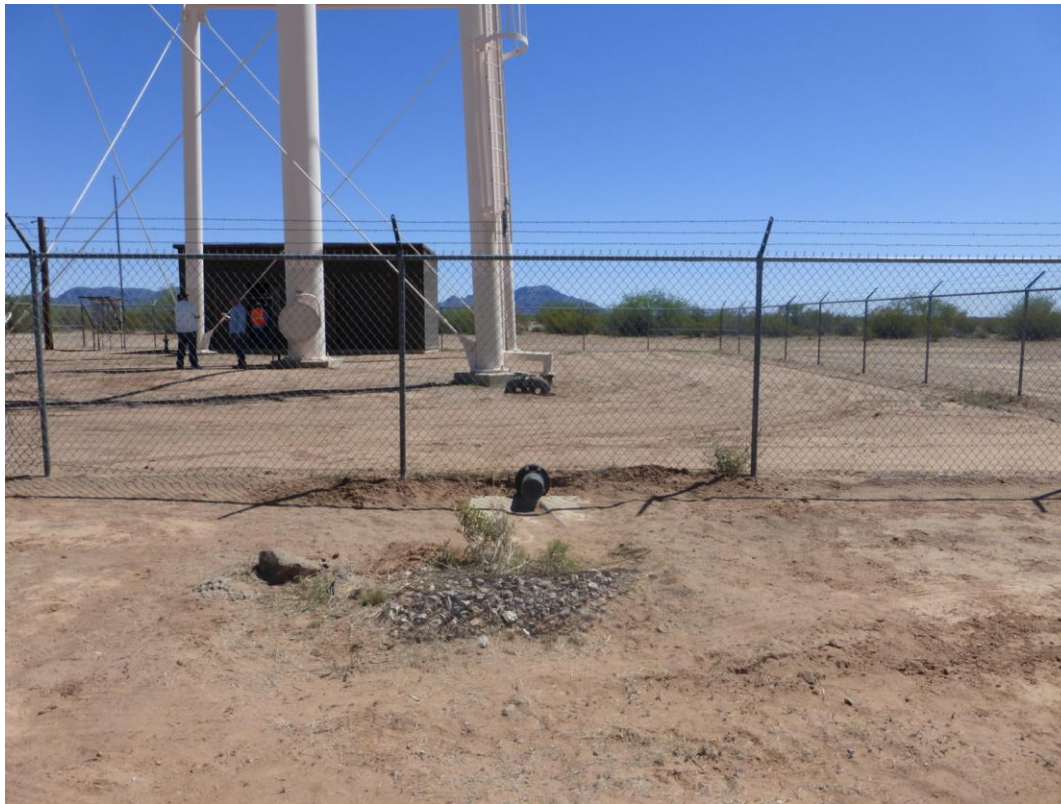
The outlet of the overflow line is screened and terminates at an adequate distance above the ground. A splash pad is provided. The tank drain line is installed below grade and connects underground to the discharge piping from the overflow line.

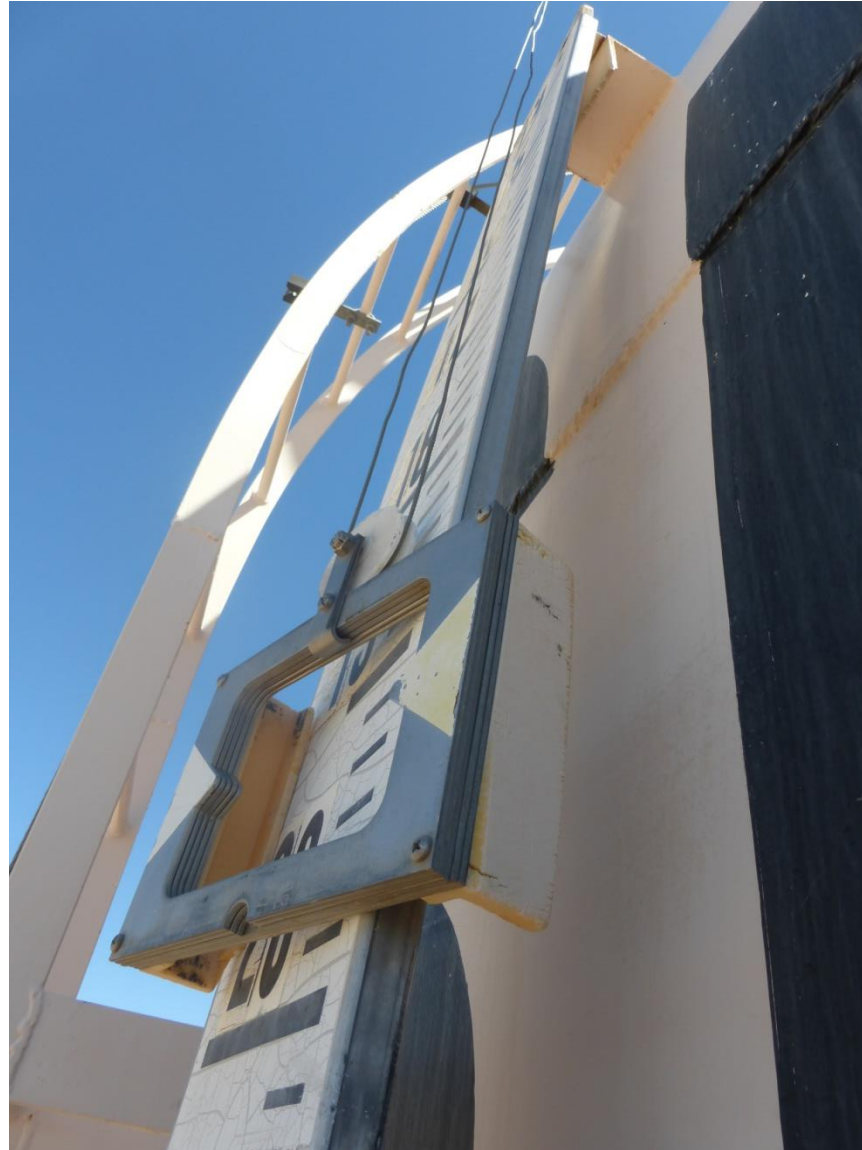
The water level target mechanism was not working at the time of the survey.

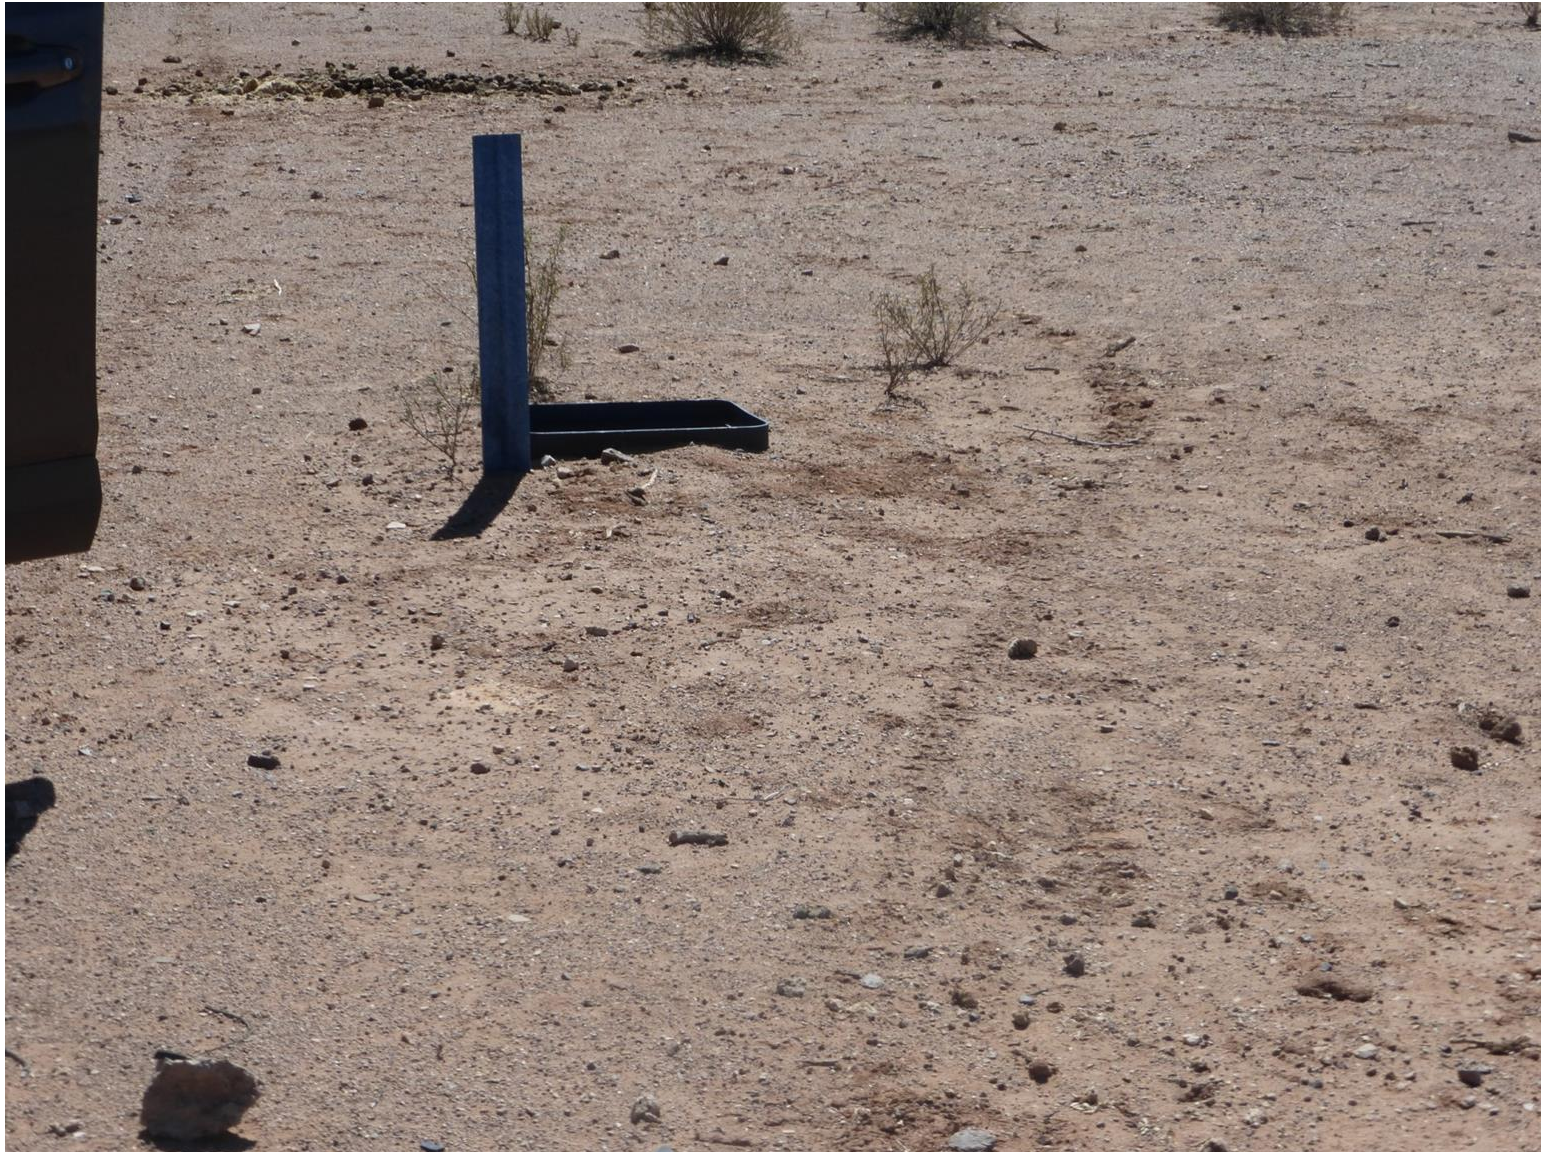
Air relief valve vault damaged by ATV. Common occurrence on this line.

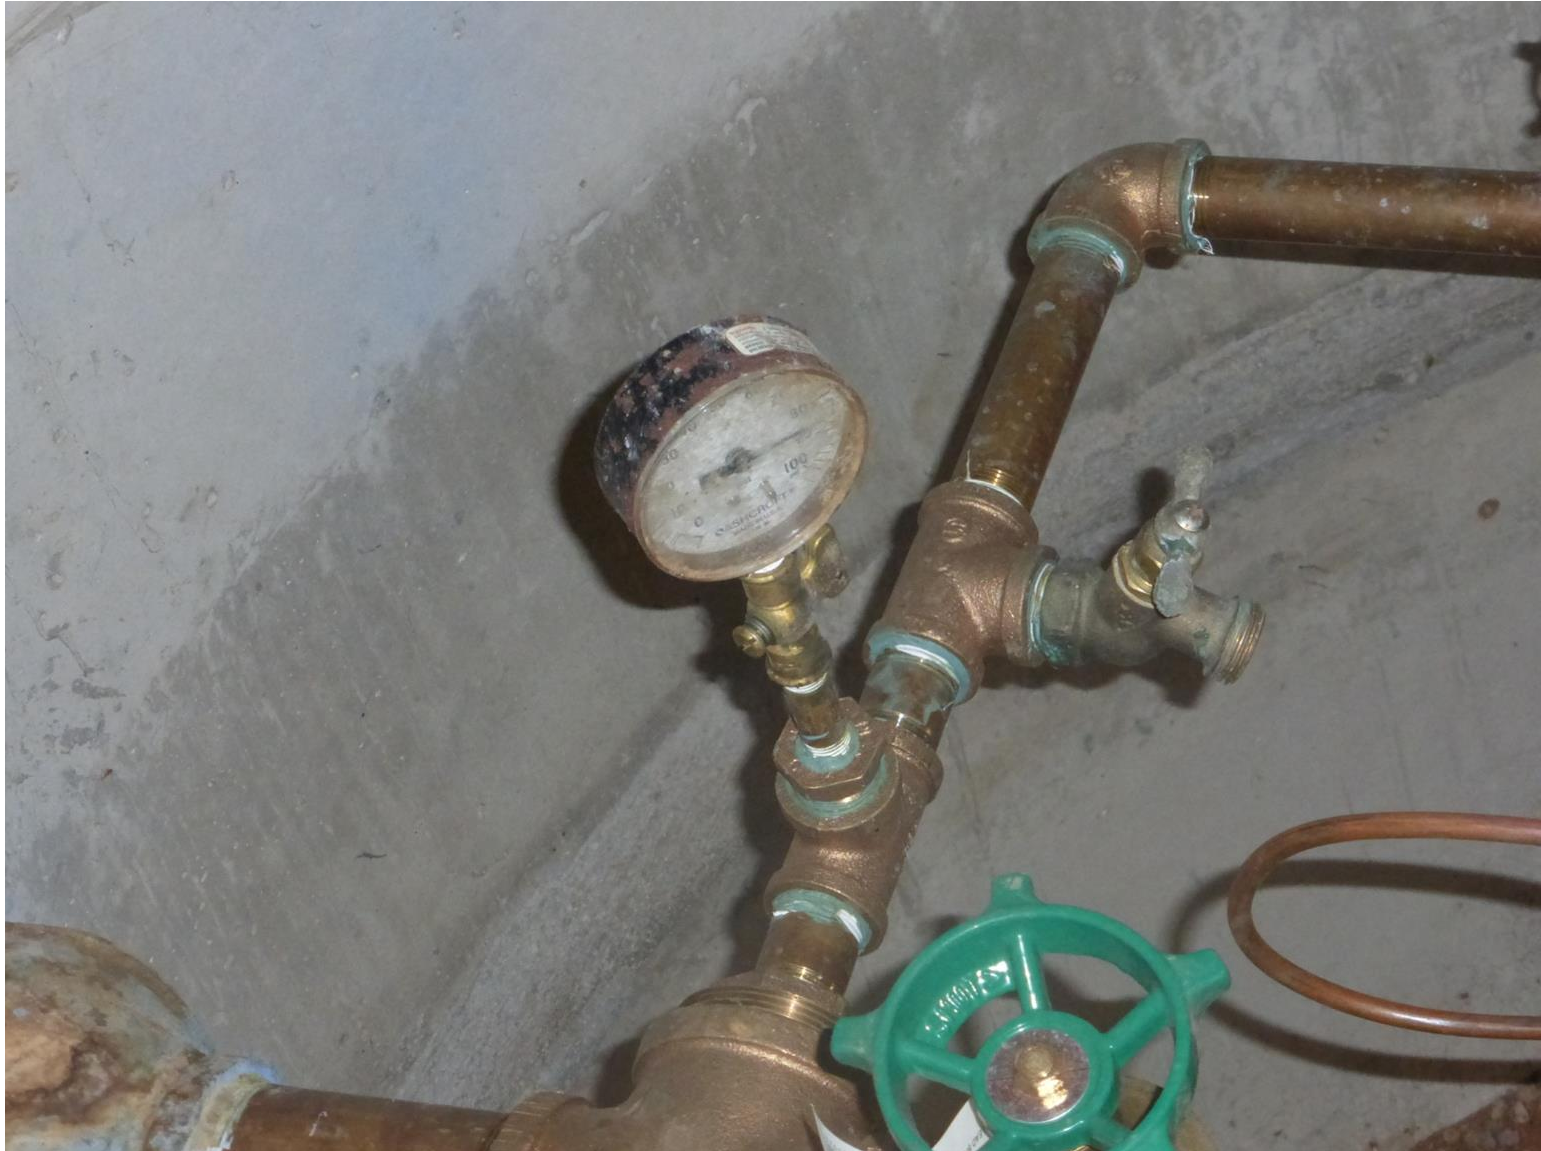
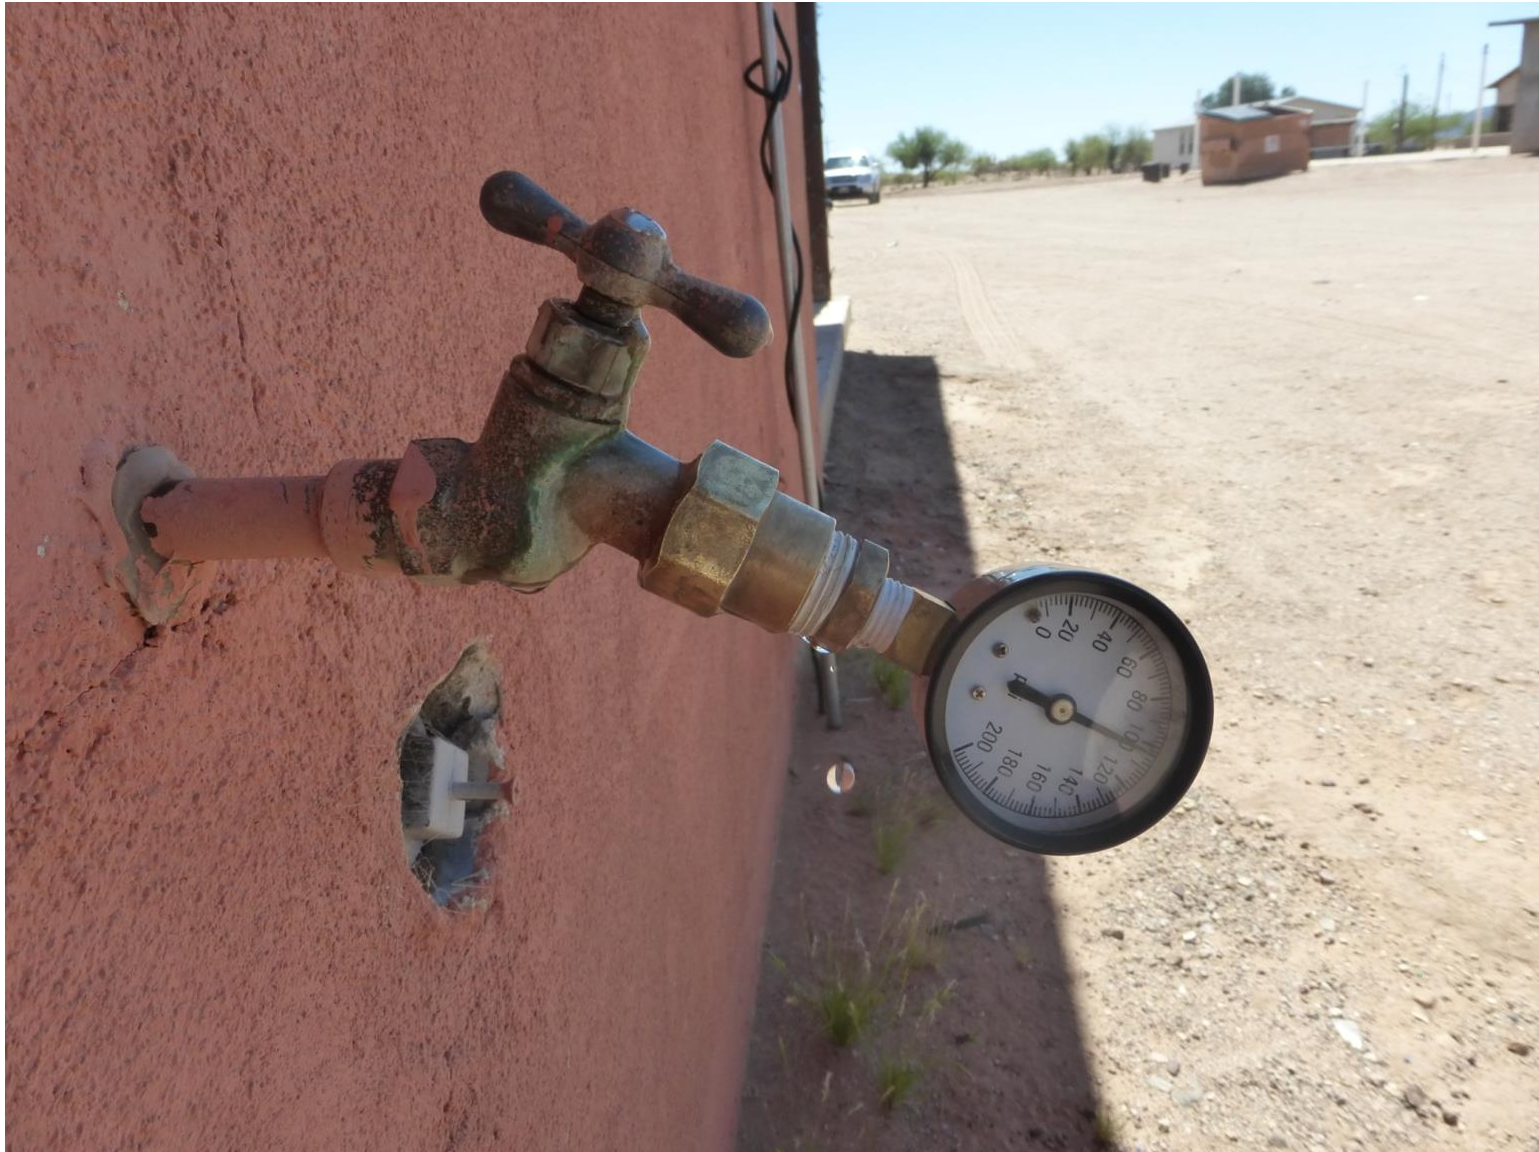
A pressure reading taken in Santa Cruz showed a reading of over 100 pounds per square inch (psi), indicating the PRV was not working.
